# **CERTS MICROGRID LABORATORY TEST BED**

Test Plan Section 7.0  
Validate Protection Settings and  
Initial Fault Testing

# **CERTS MICROGRID TEST REPORT**

*“Validate Protection Settings and Initial Fault Testing”*

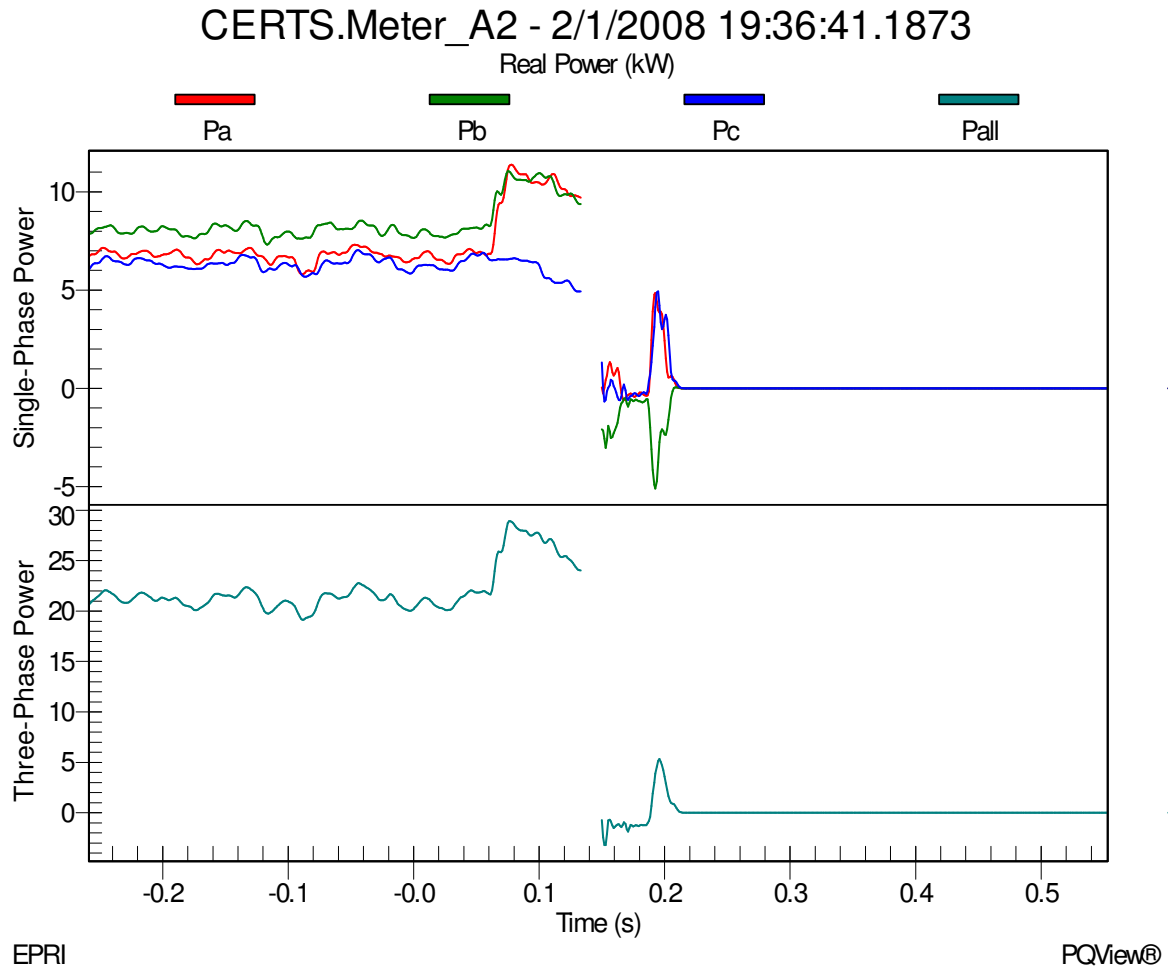
Figure 23d - Power produced by Gen-set A2 before/after the static switch opened when an A-phase toB-phase fault was applied in Zone 4.

After Gen-sets A1 and A2 were running for a few minutes and supplied power to Load Banks 3 and 4, the test started with a “Start” command from the EMS. As soon as the static switch closed and steady-state conditions established, the microgrid and Load Bank 6 were connected to the utility grid with power flow at Meter 1 being approximately 67.5kW, shown in Figure 23a, and approximately 36kW at Meter 2, shown in Figure 23b. Before the overload fault was applied, Gen-sets A1 and A2 were producing about 20kW, each shown in Figures 23c and 23d .

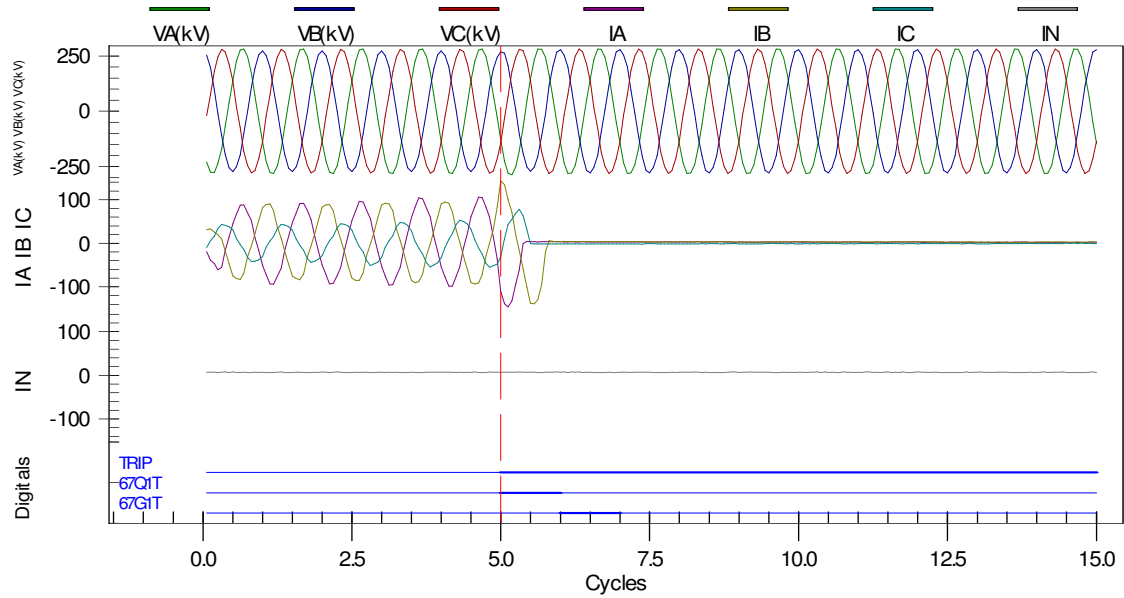
**Figure 23e - Relay 2 (static switch) tripped due to a negative-sequence over-current (67Q1T) when the phase-to-phase fault was initiated in Zone 4.**

Using the DAS Load Control program, the phase-to-phase fault on A and B phases was set for 10 seconds and then initiated. The static switch tripped in approximately 0.078 seconds (~4.7 cycles) from a negative-sequence over-current (67Q1T), shown in Figure 23e, islanding the microgrid from the utility grid. CB41 tripped, after the static switch opened, due to a negative-sequence over-current (67Q1T) isolating Zone 4 from the rest of the microgrid, and shutting down Gen-set A2, shown in Figures 23d and 23f. CB31 and CB51 remained closed throughout the 10 second phase-to-phase fault. Gen-set A1 increased its output power from approximately 20kW to 35kW, shown in Figure 23c, supplying power to Load Bank 3. Load Bank 6 was supplied power from the utility grid, shown in Figure 23a.

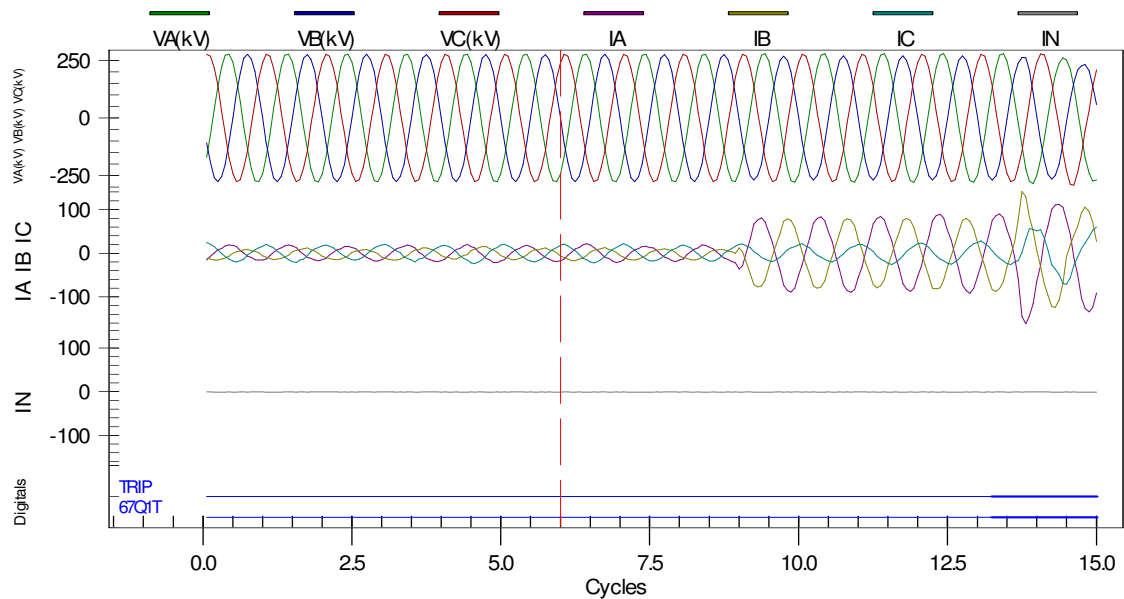
**Figure 23f - Relay 4 (CB41) tripped due to a negative-sequence over-current (67Q1T) when the phase-to-phase fault was initiated in Zone 4.**

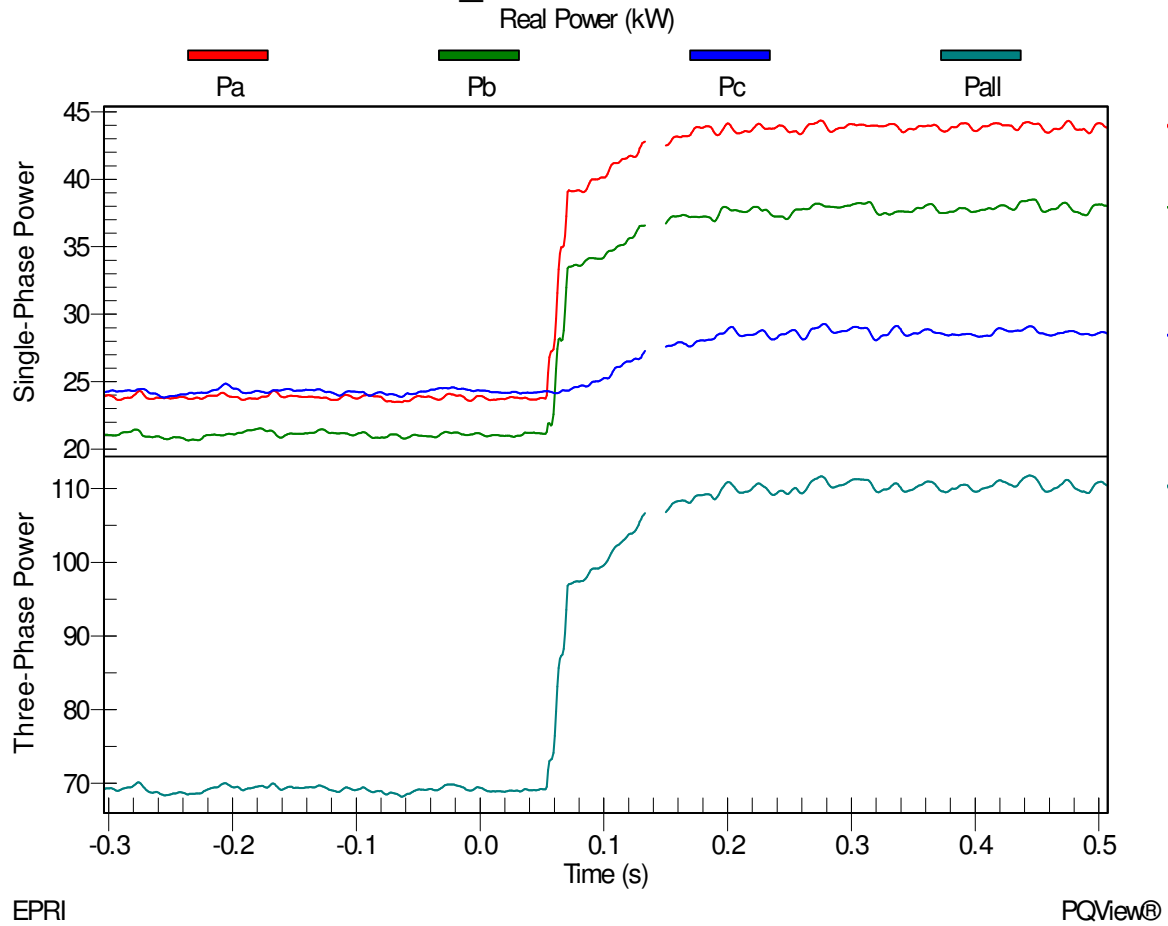
Figure 24a – Meter 1 power flow before/after the phase-to-phase fault was applied in Zone 2.

Using the DAS Load Control program, the phase-to-phase fault on A- and B- phases was set for 10 seconds and then initiated. The static switch, CB31, CB41 and CB51 did not detect enough current from Zone 2 to trip. Power flow in Meter 1, Figure 24a, increased from approximately 70kW (i.e., A-phase = 24kW, B-phase = 22kW and C-phase = 24kW) to 110 kW (i.e., A-phase = 44kW, B-phase = 38kW and C-phase = 28kW) when the fault was initiated in Zone 2. A-phase increased by approximately 20kW and B-phase by 26kW, due to the overload bank connected in Zone 2. The microgrid treated this as an unbalanced load and supplied it power by the utility grid, since both Gen-sets were set for unit power control.

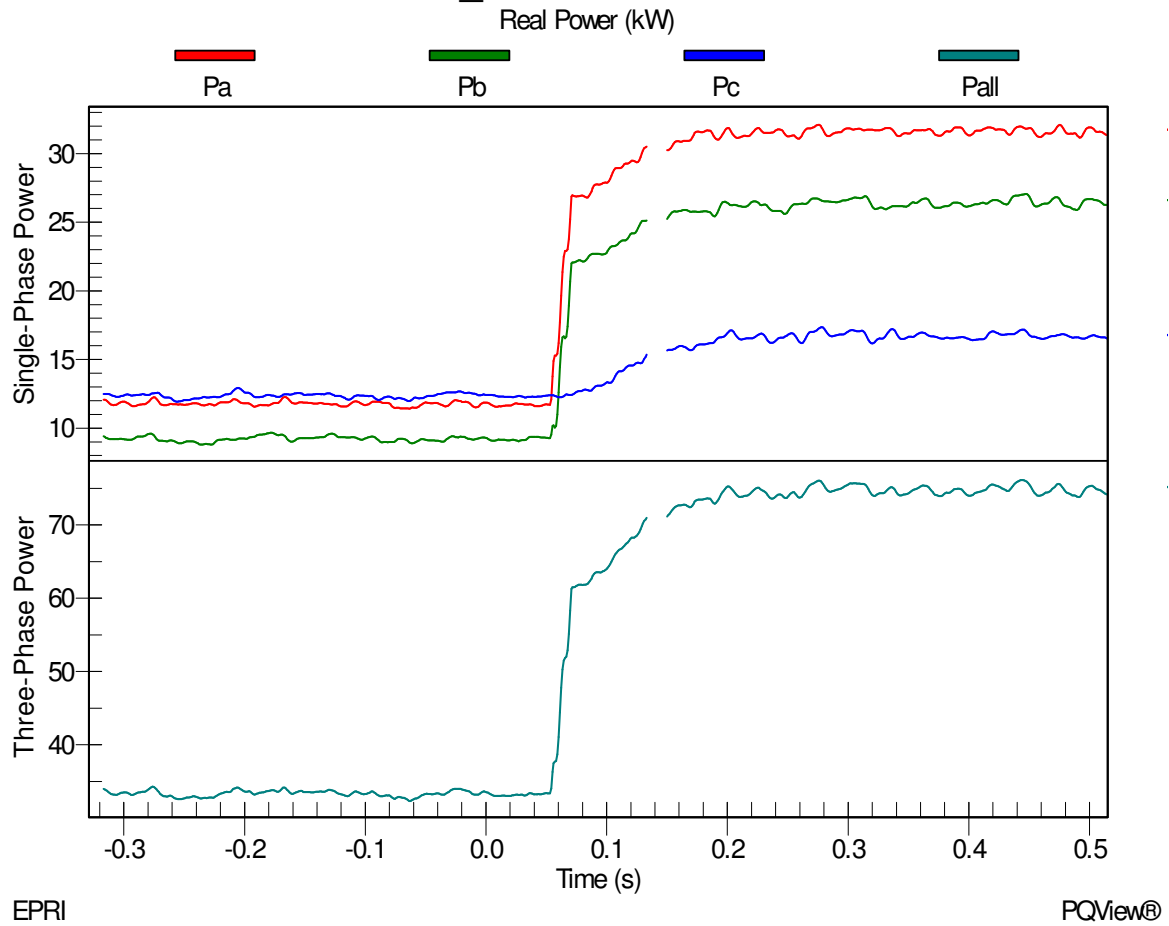
Figure 24b – Meter 2 power flow before/after the phase-to-phase fault was applied in Zone 2.

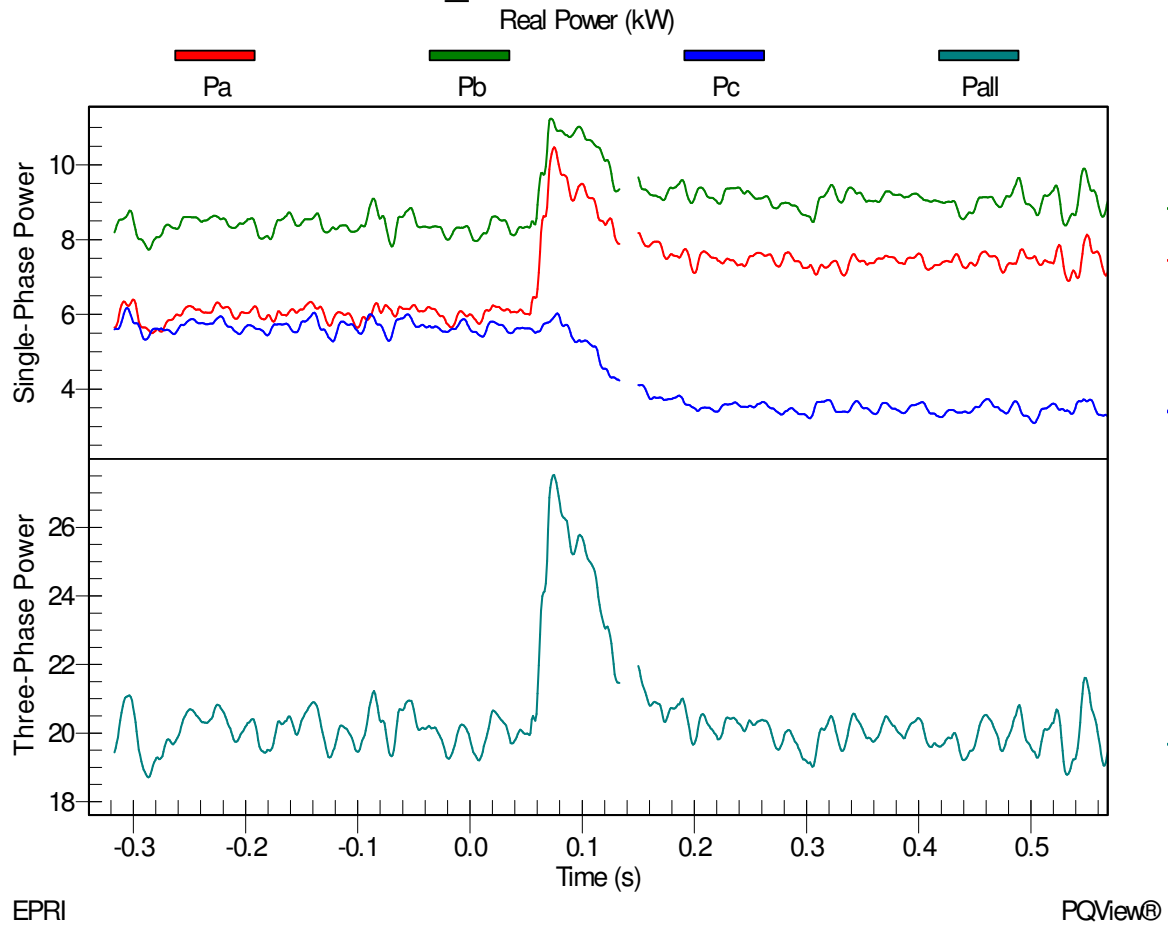
Figure 24c - Power produced by Gen-set A1 before/after an A-phase to B-phase fault was applied in Zone 2.

After Gen-sets A1 and B1 were running for a few minutes and supplied power to Load Banks 3 and 5, the test started with a “Start” command from the EMS. As soon as the static switch closed and steady-state conditions established, the microgrid and Load Bank 6 were connected to the utility grid with the total power flow at Meter 1 being approximately 70kW, shown in Figure 24a, and approximately 34kW at Meter 2, shown in Figure 24b. Before the overload fault was applied, Gen-sets A1 and B1 were producing about 20kW each, shown in Figures 24c and 24d.

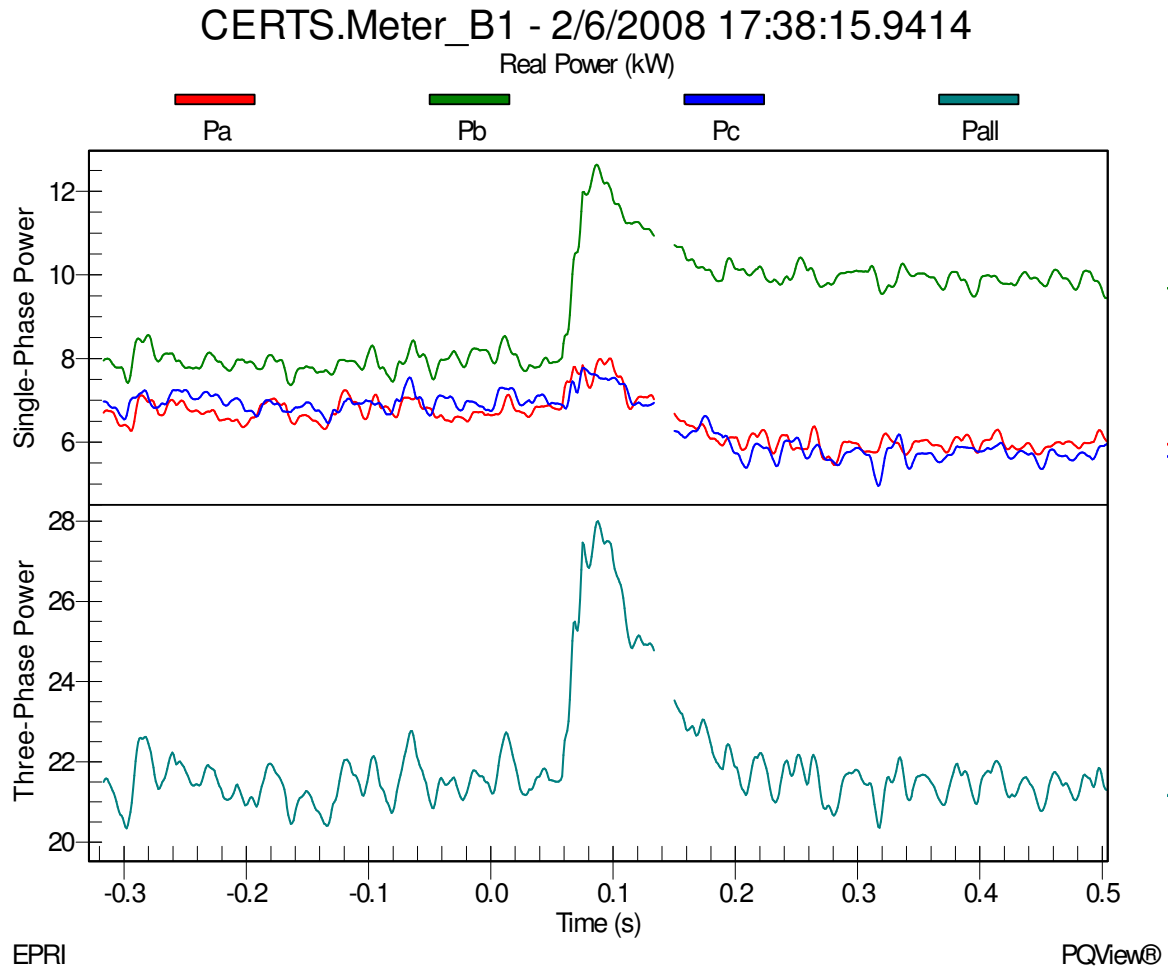
**Figure 24d - Power produced by Gen-set B1 before/after an A-to-B phase-to-phase fault in Zone 2 is applied**

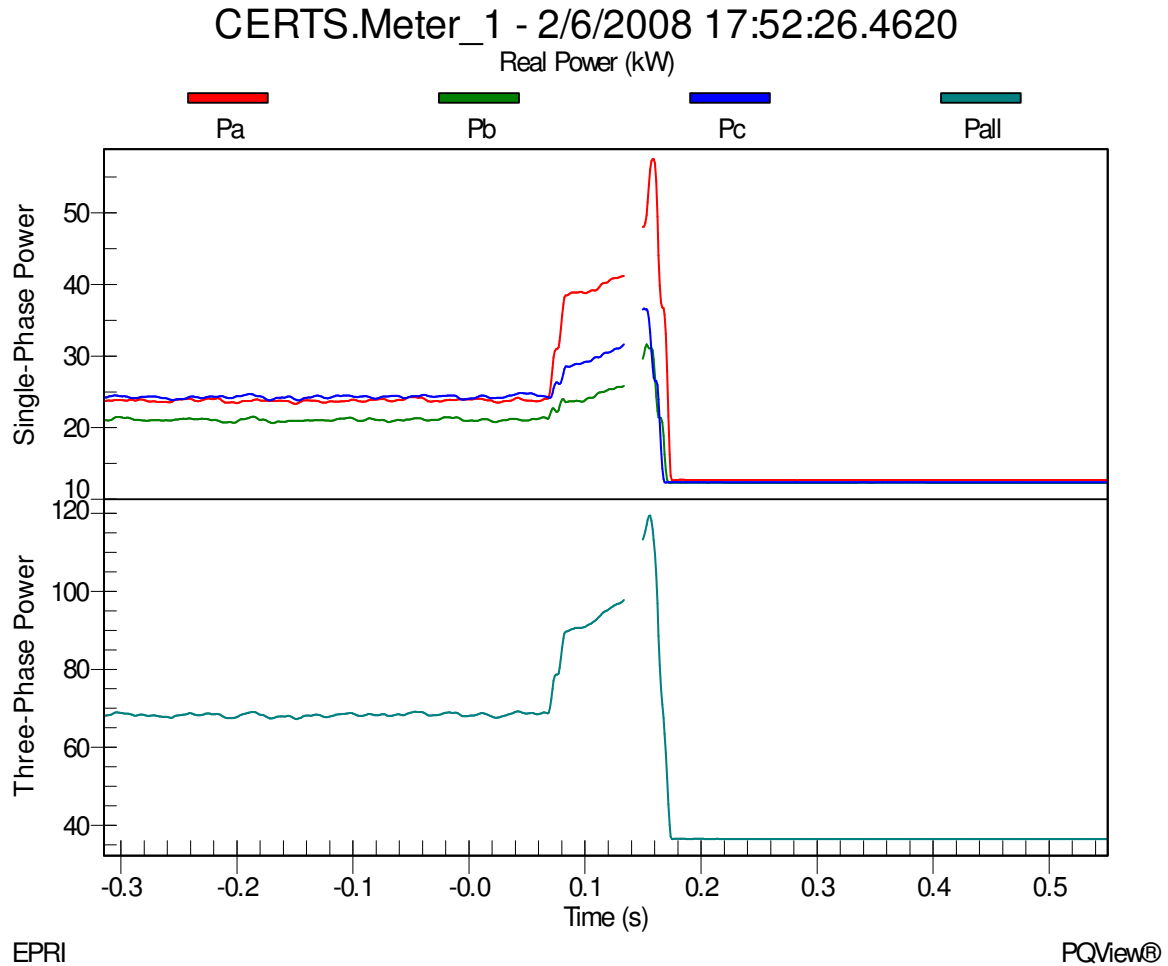
**Figure 25a – Meter 1 power flow before/after the static switch opened, islanding the microgrid from the utility grid when a phase-to-phase fault was applied in Zone 5.**

Bank 6 were connected to the utility grid with the total power flow at Meter 1 being approximately 69kW, shown in Figure 25a, and approximately 34kW at Meter 2, shown in Figure 25b. Before the overload fault was applied, Gen-sets A1 and B1 were producing about 20kW and 22kW, respectively, with each shown in Figures 25c and 25d.

25c, supplying power to Load Bank 3. Load Bank 6 was supplied by the utility grid, shown in Figure 25a.

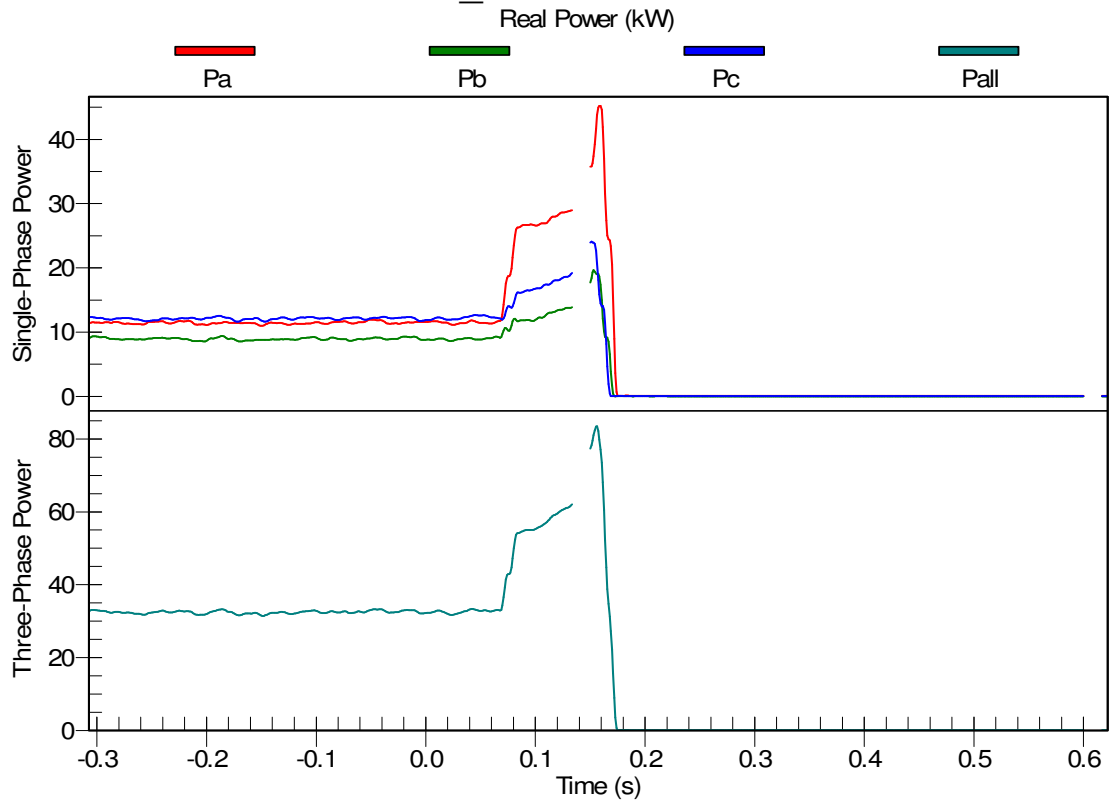
Figure 25b – Meter 2 power flow before/after the static switch opened, islanding the microgrid from the utility grid when a phase-to-phase fault was applied in Zone 5.

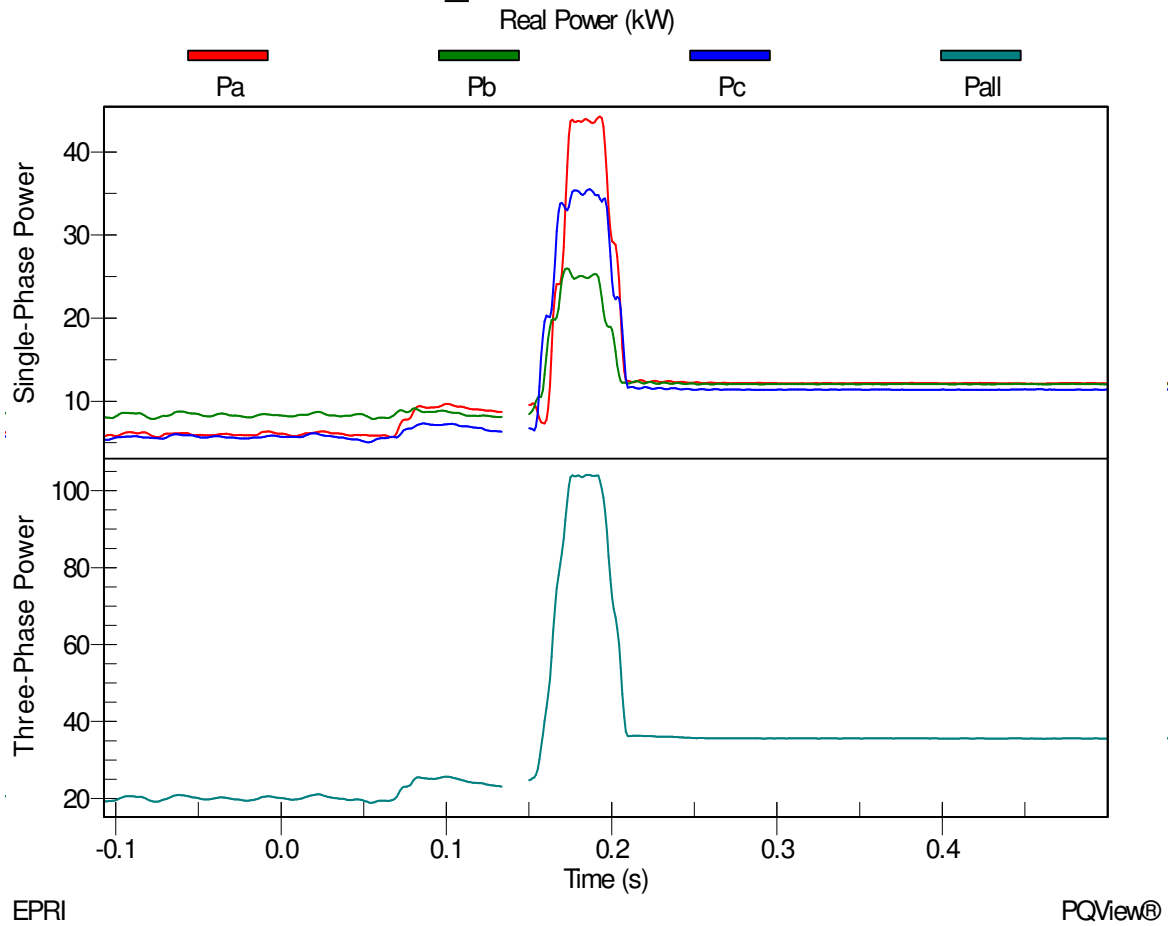
Figure 25c - Power produced by Gen-set A1 before/after the static switch opened from an A-phase to B-phase fault in Zone 5.

CB31 and CB41 remained closed throughout the 10 second phase-to-phase fault. Gen-set A1 increased its output power from approximately 21kW to 36kW, shown in Figure

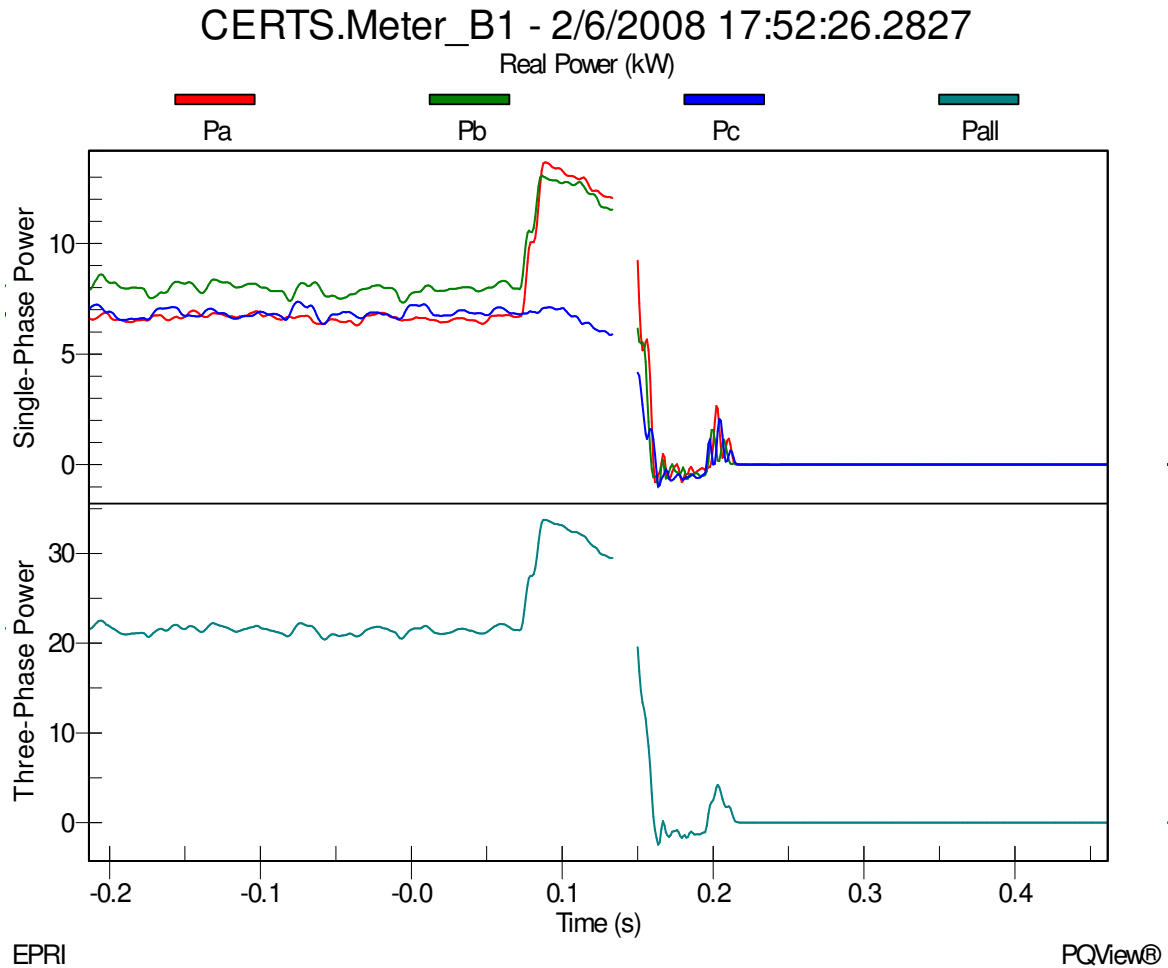
**Figure 25d - Power produced by Gen-set B1 before/after the static switch opened from an A-phase to B-phase fault in Zone 5.**

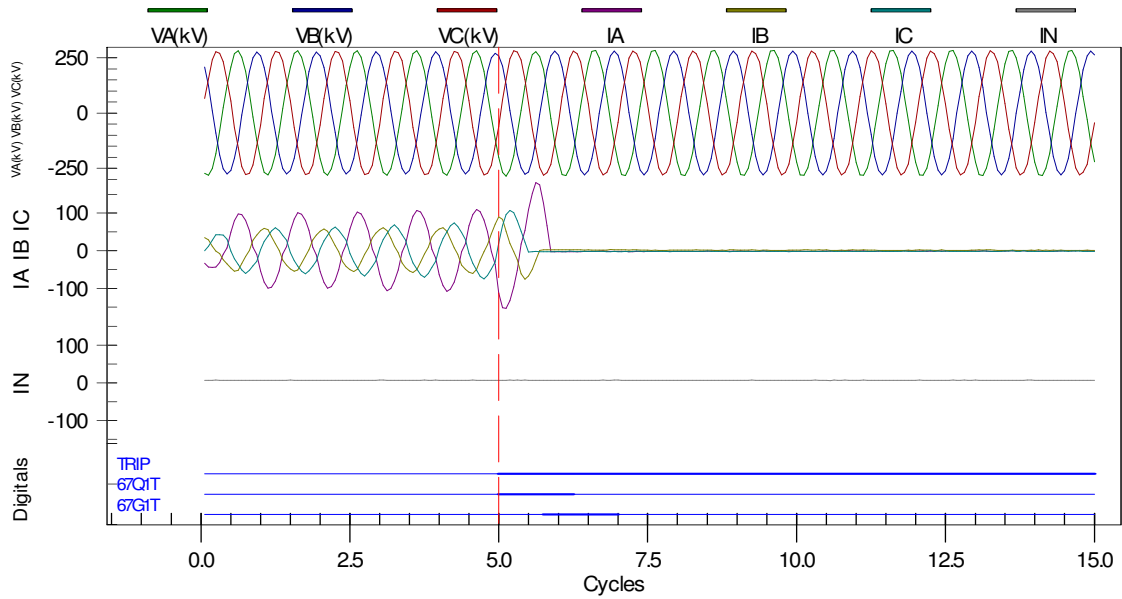
**Figure 25e - Relay 2 (static switch) tripped due to a negative-sequence over-current (67N1T) when the phase-to-phase fault was initiated in Zone 5.**

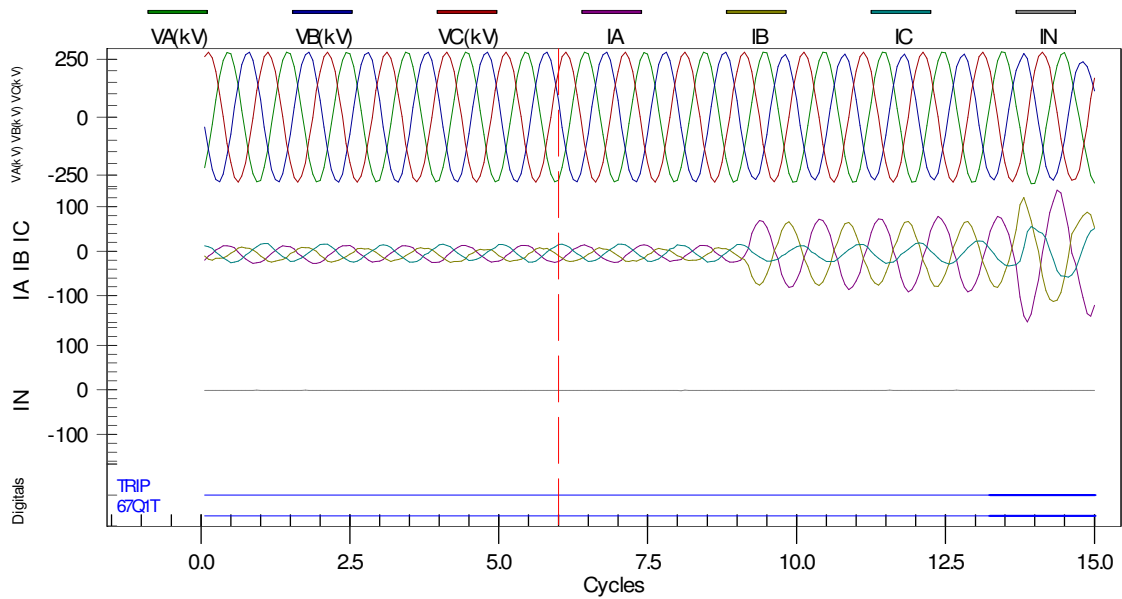
**Figure 25f – Relay 5 (CB51) tripped due to a negative sequence over-current (67N1T) when the phase-to-phase fault was initiated in Zone 5.**

Using the DAS Load Control program, the phase-to-phase fault on A- and B-phases was set for 10 seconds and then initiated. Relay 5 tripped in approximately 0.075 seconds (~4.5 cycles) from a negative-sequence over-current (67N1T), shown in Figure 25f. Gen-set B1 stopped switching its output even though its transformer contactor and CB51 remained closed, shown in Figure 25g. This loss of generation increased the negative sequence current seen by the static switch enough to cause it to trip within approximately 0.016 seconds (~1 cycle), shown in Figure 25e. Gen-set A1 increased its output briefly to support the load in Load Banks 3 and 5, as well as the overload fault. After approximately 0.043 seconds (~2.5 cycles) CB51 cleared and Gen-set A1 remained on-line, supplying power to loads in zones 2, 3, and 4.

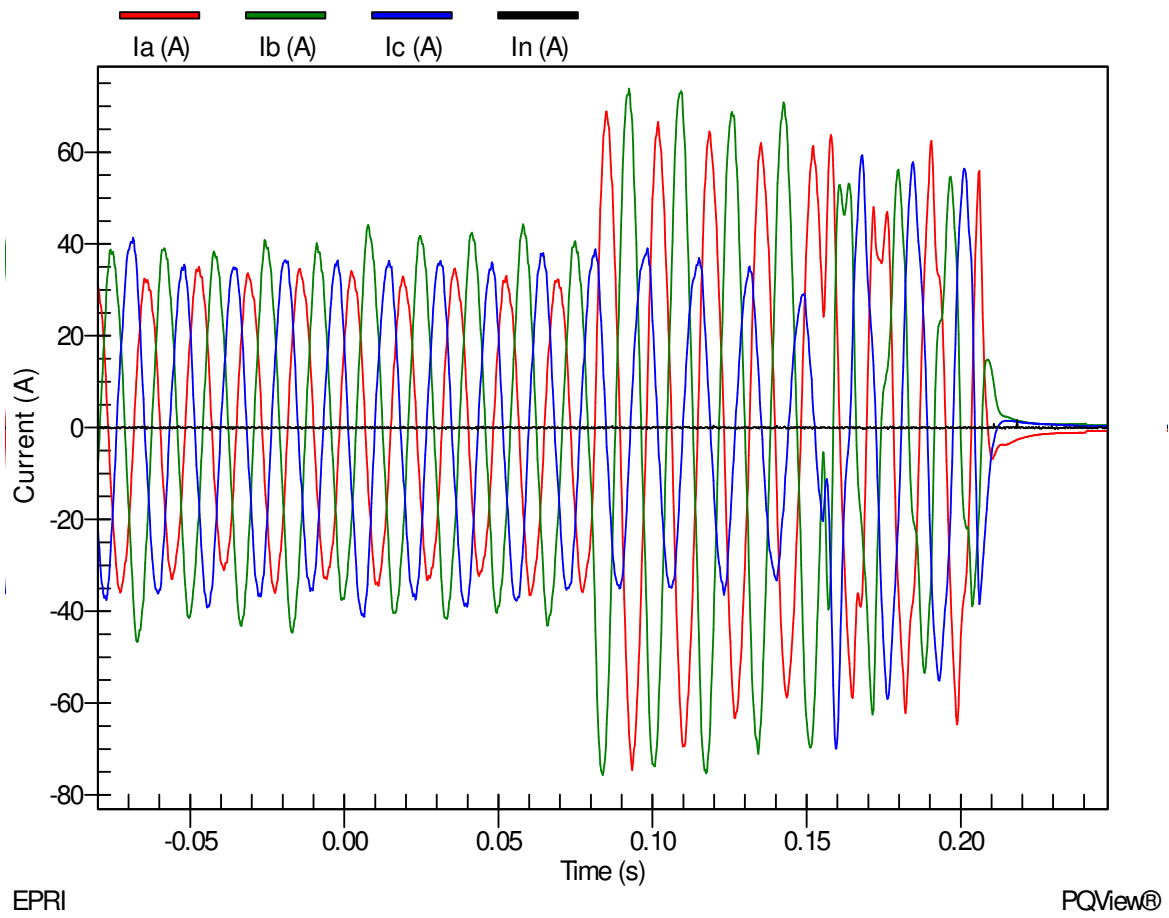
Figure 25g – Gen-set B1 current before/after a phase-to-phase fault was initiated in Zone 5.

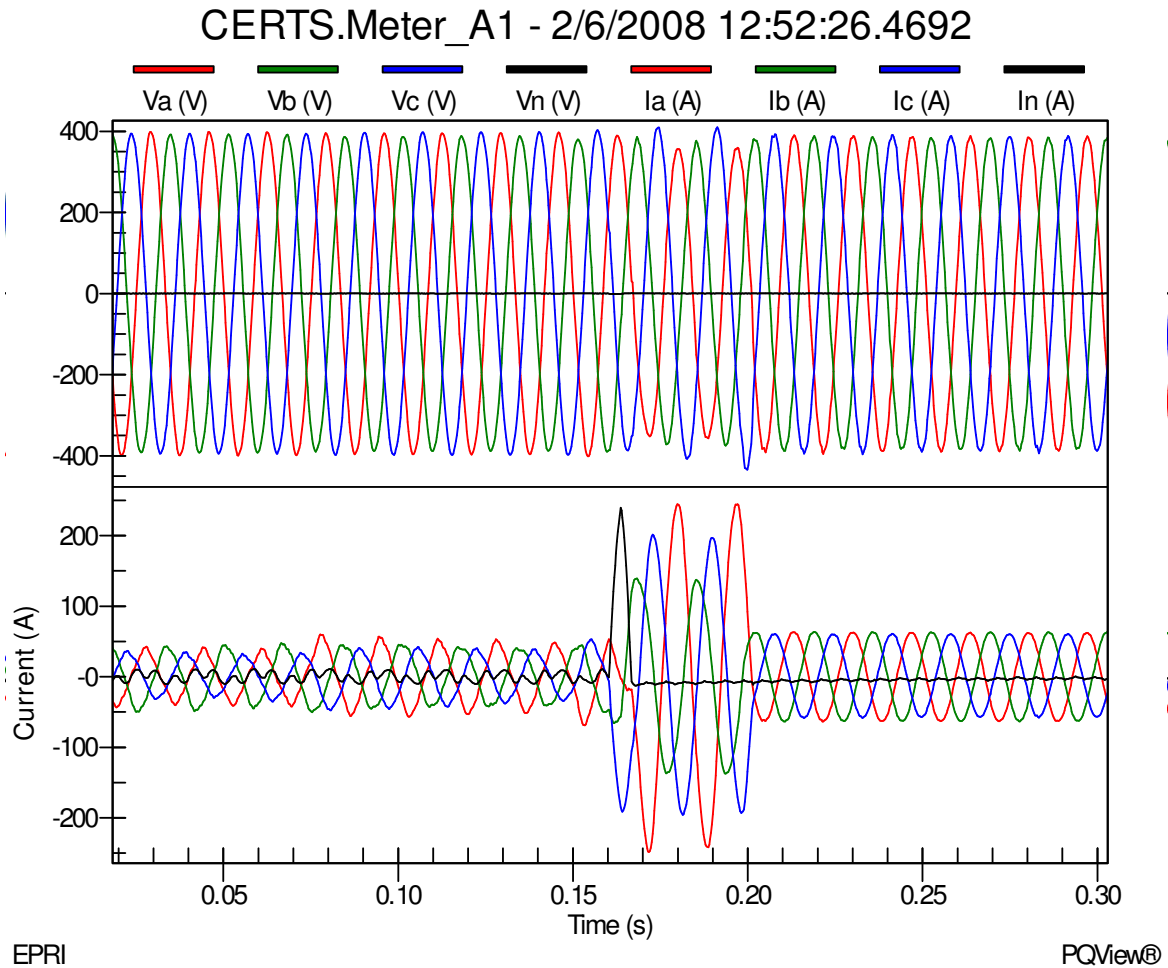
Figure 25h – Gen-set A1 current before/after a phase-to-phase fault was initiated in Zone 5.
